**DEPARTMENT OF TRANSPORTATION**

Contract #: 04-0120F4Cty: SF/ALA Rte: 80 PM: 13.2/13.9File #: 69.28**WELDING INSPECTION REPORT****Resident Engineer:** Pursell, Gary**Address:** 333 Burma Road**City:** Oakland, CA 94607**Report No:** WIR-002438**Date Inspected:** 18-May-2008**Project Name:** SAS Superstructure**OSM Arrival Time:** 1700**Prime Contractor:** American Bridge/Fluor Enterprises, a JV**OSM Departure Time:** 800**Contractor:** Zhenhua Port Machinery Company, Ltd (ZPMC), Changxing Island **Location:** Changxing Island

Caltrans Quality Assurance (QA) Inspector, Larry Viars was present to perform Visual Testing (VT) of the Orthotropic Box Girder (OBG) components, for the San Francisco Oakland Bay Self Anchored Suspension Bridge, at Zhenhua Port Machinery Company (ZPMC) facility on Changxing Island.

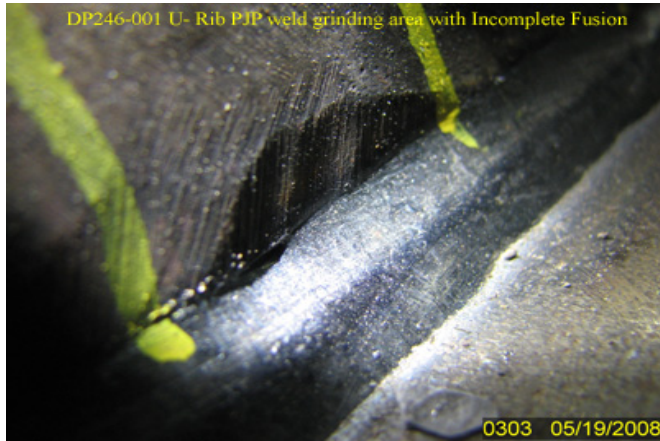
The Caltrans QA Inspector performed visual inspection of OBG 19.995 meter deck panel DP246-001-001 (welds 001 through 009) U-rib Partial Joint Penetration (PJP) welds. Visual testing of welding was performed in accordance with contract documents. The following discontinuities were found during inspection on the Submerged Arc Welding (SAW) cover pass, incomplete fusion, overlap, undercut, underfill and oversize welds. Welding discontinuities were marked on deck panel with a permanent marker, length and Y location recorded. Visual Inspection results were distributed to the appropriate personnel for review. A summary of discontinuities on inspected U- rib PJP welds are listed below. Please see photo below of grinding area with Incomplete Fusion.

DP246-001-001, Incomplete Fusion 79 areas, Underfill 16 areas, and Overlap 6 areas
